## Surface Defects and their Control in Hot Dip Galvanized and Galvannealed Sheets

P. Saravanan, S Srikanth

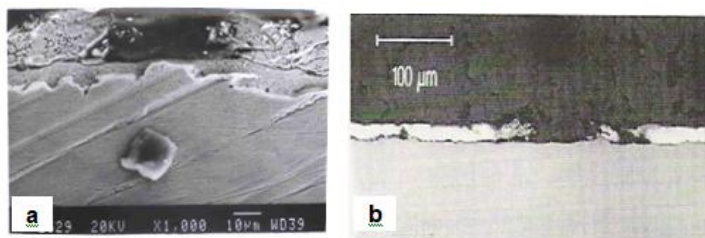
**Fig1.** Bare spots in hot dip galvanized coatings [a] SEM micrograph, [b] Optical micrograph

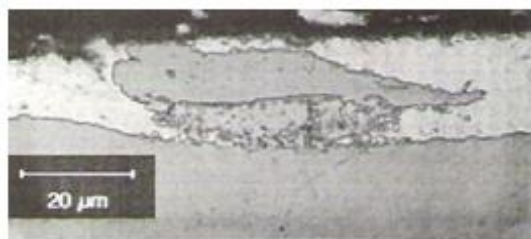
**Fig6.** Fe fines partly transformed into Fe-Zn intermetallic compounds in a Galvanized coating

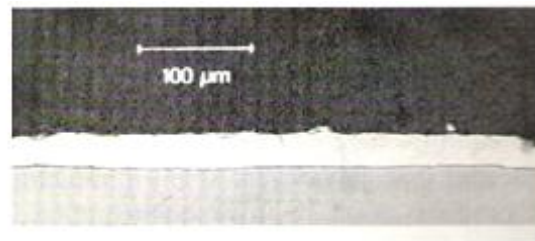
**Fig7.** Cross-sectional view through a shiny spot where the coating was thicker than surrounding coating and was flattened during temper-rolling

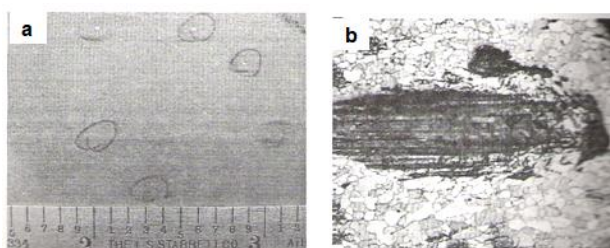
**Fig9.** Coated-over substrate scratch defect [a] Visual appearance and [b] Micrograph of the surface of the defect (140X)

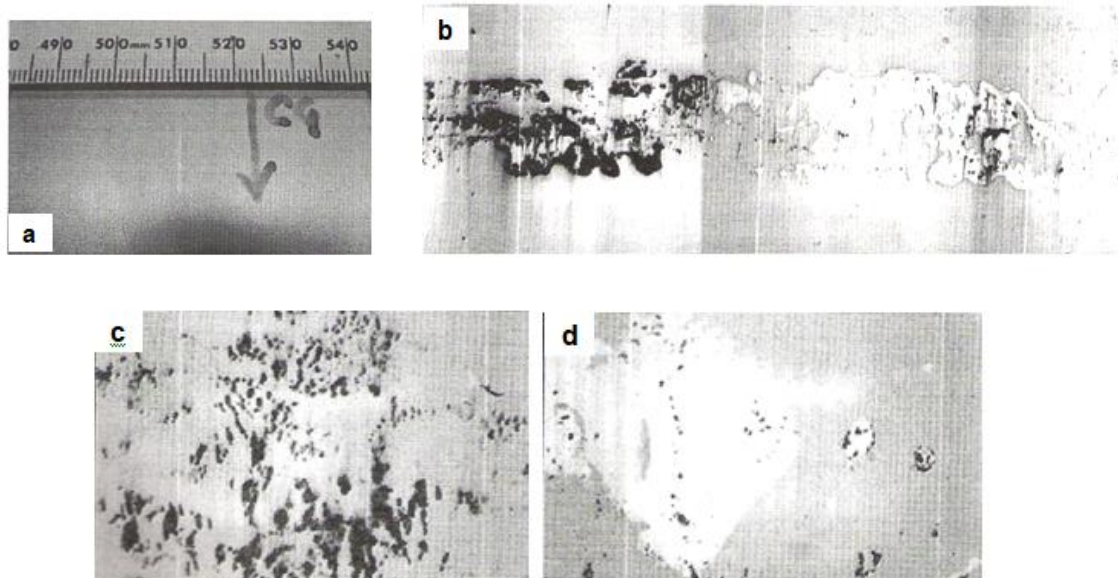
**Fig10.** Coating defect originating from rolled-in scale [a] Visual appearance of faint and short line defect, [b] Surface micrograph taken after polishing (35X), [c] Surface micrograph showing the embedded scale (350X) and [d] Micrograph showing entrapped scale in zinc pits (350X)

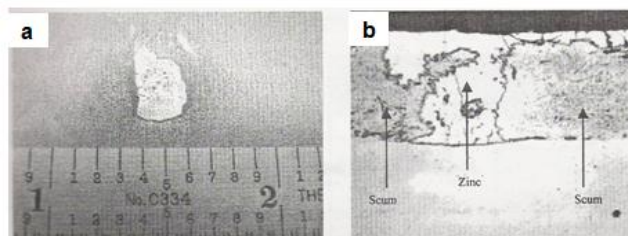
**Fig11.** Tandem rolled-in scum in a galvannealed coating [a] Coated-over scum and [b] Cross-sectional microscopic view of the defect (350X)

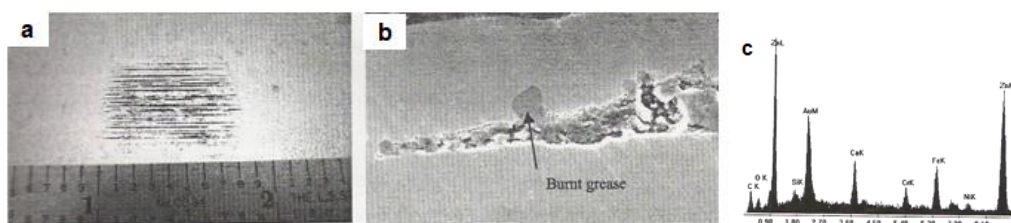
**Fig12.** Coated-over grease defect in galvanized sheet [a] Visual appearance of the defect, [b] Cross-sectional microscopic view (1000X) and [c] EDS analysis of coated-over grease

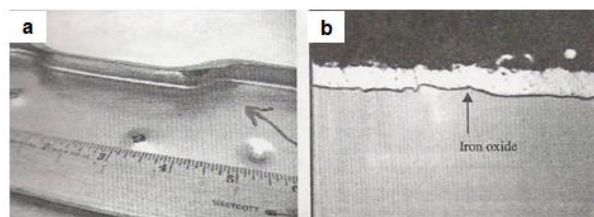
**Fig13.** Poor adherence due to interfacial iron oxide layer [a] Visual appearance of the formed part showing poor adherence and [b] Cross-sectional microscopic view of the specimen showing interfacial iron oxide

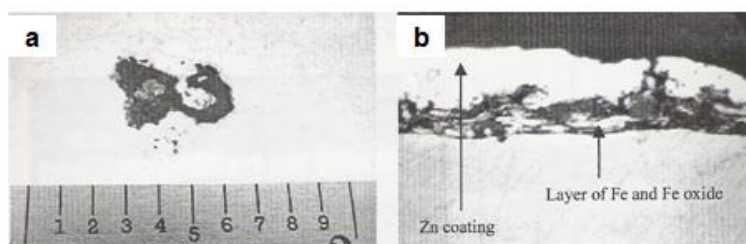
**Fig15.** Coated-over hearth-roll pickup scum defect [a] Visual appearance of the defect and [b] Cross-sectional microscopic view at the vicinity of the defect (700X)

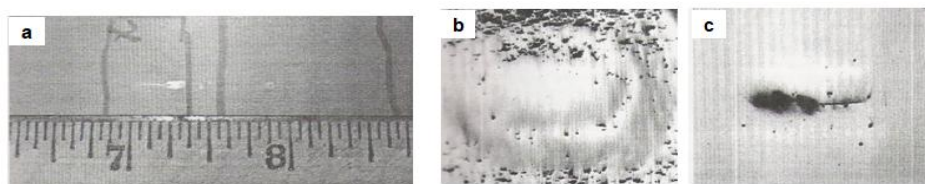
**Fig16.** Coating defect caused by entrapped gas from galvannealing furnace atmosphere [a] Visual appearance of the defect, [b] Micrograph of the surface after light polishing (35X) and [c] Same field after further polishing (140X)

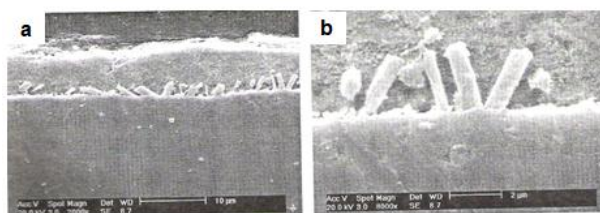
**Fig17.** Interfacial blocky zeta particles at the coating-steel interface in a sheet galvanized in low Al bath [a] Cross-sectional microscopic view at 2000X and [b] Same field at 8000X

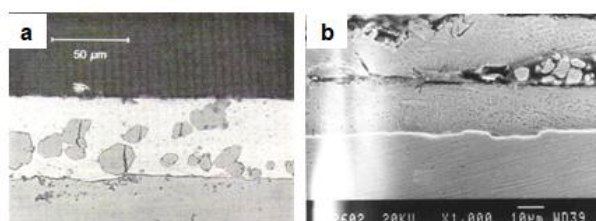
**Fig19.** Entrapped dross particles in galvanized coatings [a] Dross particles together with patch of oxide skin and [b] SEM view of the defect in another specimen

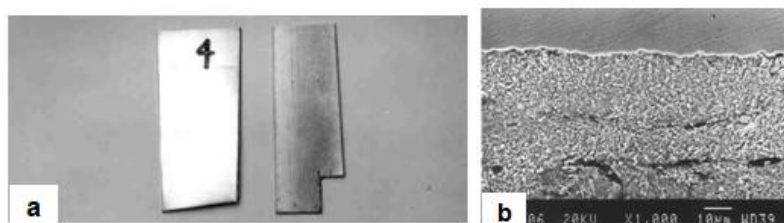
**Fig20.** Non-spangled, dull and matte coating appearance in hot dip galvanized sheet [a] Photograph illustrating visual appearance and [b] SEM micrograph of the defect showing entrapped bottom dross particles in the coating

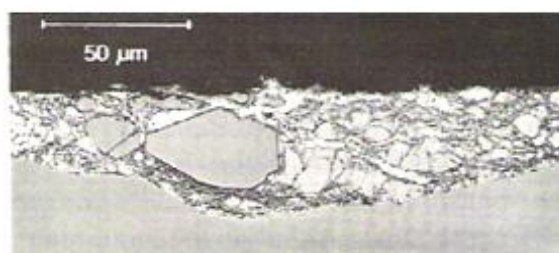
**Fig21.** Entrapped dross particles in a galvanized coating after galvannealing to galvanizing bath transition; these particles created print-through defects in the coating after temper-rolling

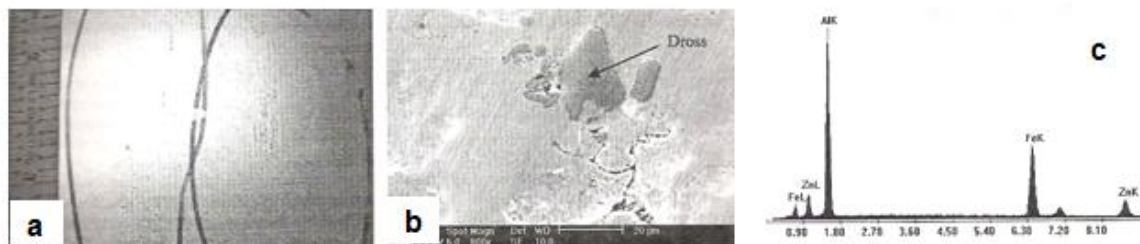
**Fig22.** Dross pickup defect in galvannealed coating [a] Visual appearance of the defect, [b] SEM view of the dross particles (800X) and [c] EDS analysis of the dross particles

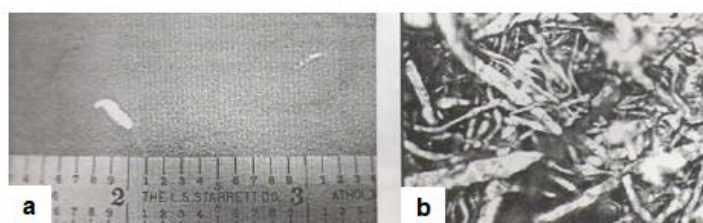
**Fig23.** Zinc dust pickup on galvannealed coating [a] Visual appearance of the defect and [b] Optical microscopic view of the zinc dust (700X)

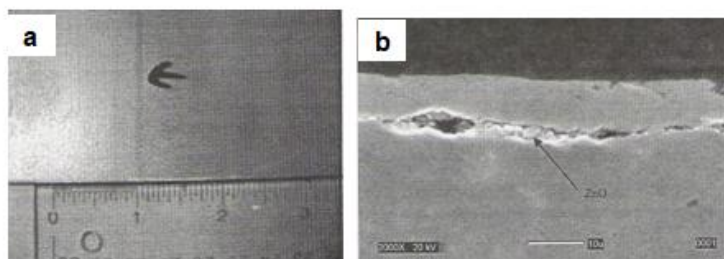
**Fig.24** Zinc oxide pickup in snout as observed in a galvannealed coating [a] Visual appearance of the dark line defect and [b] Cross-sectional view under SEM revealing entrapped zinc oxide at the coating-steel interface

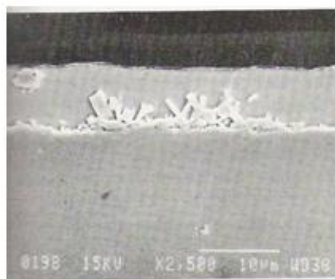
**Fig25.** Zn-Fe crystallites formed in a galvanized coating due to a relatively low bath effective Al level

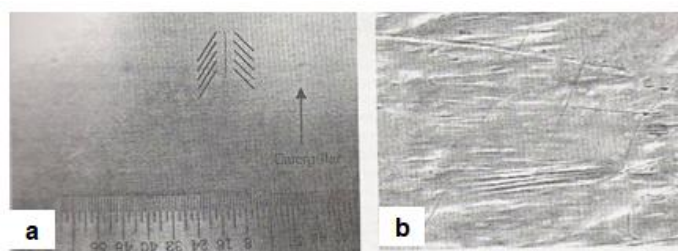
**Fig26.** Caterpillar coating defect originating from air wiping in a galvanized sheet  
[a] Visual appearance and [b] SEM view of the flow lines associated with the defect

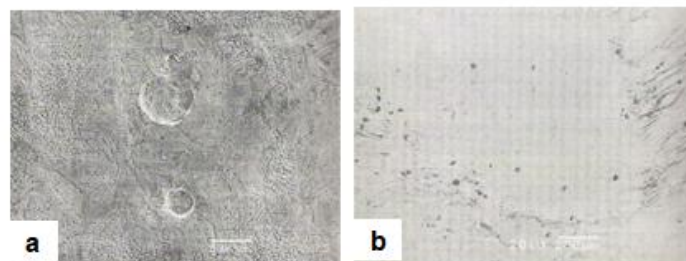
**Fig27.** Dent type defects in hot dip galvanized coatings [a] due to impingement of water droplets from mini-spangle rig and [b] due to temporary air wiping jet disturbance encountered as entrapped iron fines are blow away from the mushy, semi-solid coating
