An Update on the Use of Fiberglass Casing and Tubing in Oil and Gas Wells

Abstract: *Thirty years after the last paper on the subject, an update is required. This paper initially outlines a basic review of fiberglass piping in the industry and the manufacturing process. Field issues identified through literature, interviews and operator experiences have been presented and analyzed. Methods and avenues to address these issues have been researched, and a look to the future of fiberglass in the field is provided. Pipe failure, logging, joining methods, fire safety, and handling have been addressed. Generally, as fiberglass accumulates further field-experience, issues and obstacles have been overcome generating many successful case histories around the world.*

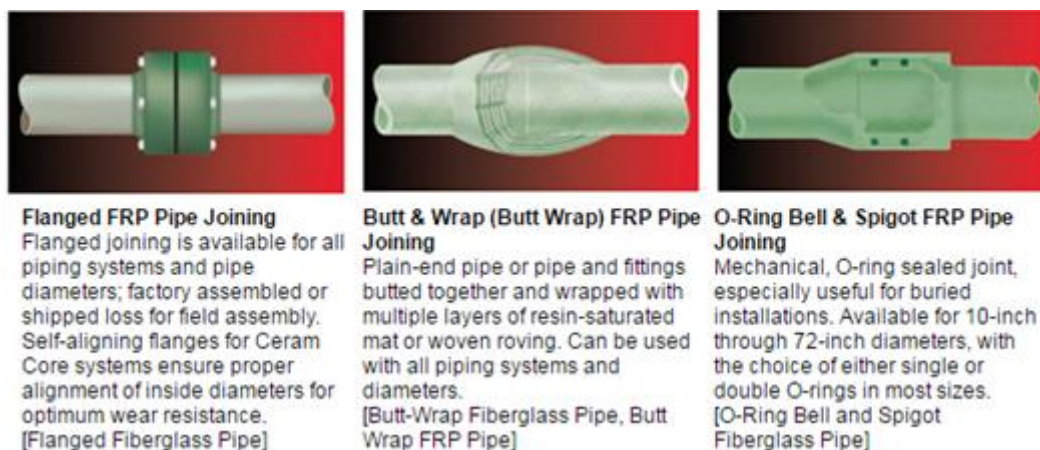
Figure6. Type of Joints available for Fiberglass Tubulars from a Manufacturer

Manufacturers now provide a large number of solutions to these problems, with high performance flanges and new curing methods (Fig. 6). In addition, industry standards for fiberglass joining technology have been developed, such as EUE 8RD, OD 8RD and API 5B. Despite several standards and benchmarks being available for joints, there seems to be a discrepancy amongst standards for employing fiberglass tubular-joints as a whole. In the 1980's several complaints of the absence of standards and certifications were voiced (Williams 1988). Almost three decades later, several codes, benchmarks and standards have been developed but there seems to be an inadequacy on the industry's part with respect to having adopted these standards in a uniform manner. Research on numerous manufacturers of fiberglass reveals that almost all marketers prove to hold one form of certification/standard or another, yet these standards are by no means common as different suppliers adhere to different standards. Additionally, an operator has the freedom to choose what type of fiberglass to employ, and in which application. Each pipe design adheres to, or is certified by, a different institution or agency. As a result, the rules and standards for fiberglass casing and tubing can be very confusing and ambiguous, and fail to address the unique properties of fiberglass in terms of downhole performance. This underscores the need to update installation and testing guidelines for fiberglass (Hawkins 2006), in order to provide an industry-wide best practice and uniform implementation standard. ISO14692 aims to provide an international standard for fiberglass manufacturers but only has sparse references to field application and joints. In terms of universal acceptance, independent researchers have attempted to develop standardized methodologies to help provide a means to judge the image and perceptions of companies and products in the fiberglass-tubular industry (Holtzclaw 1998). Rookus (2010) presents an extensive review of standards and guidelines for fiberglass tubulars and notes that these standards are heavily dependant on operators' experiences in the field, and shall become more reliable and effective with increased use of fiberglass tubulars downhole. It is therefore a case where a young industry trend needs to mature with an accumulation of field experiences in order to replace older, steel technologies.

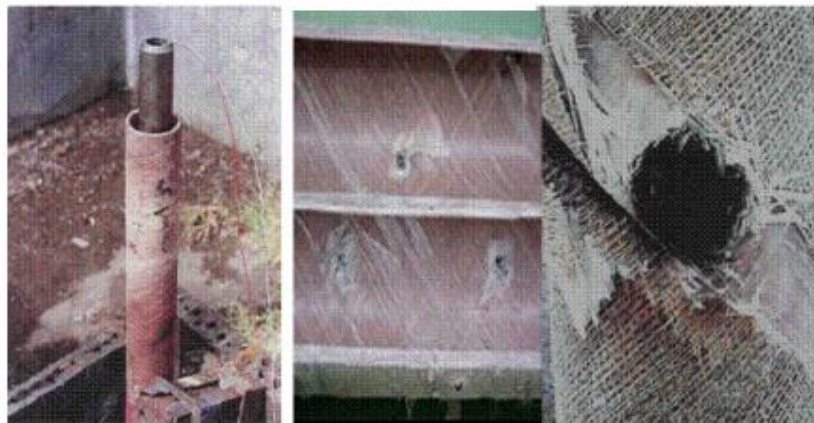
Figure8. Results of Perforation of Fiberglass Casing

Perforations using shallow penetration guns have had no reported complications. However, deep penetration charges and capsule-type guns cause damage to the fiberglass tubulars, creating a rough hole which leaves debris on the tubular (**Fig.8**). This debris can then cause further problems for other equipment like gauging instruments and packers. These issues are either remedied by using strictly shallow-penetration charges, hollow carrier guns, or using weight bars on baskets for gauging operations, so as to prevent them from getting stuck in perforation debris (Romera et al. 2008). In addition to capsule-type perforation guns, other equipment unsuitable for fiberglass tubulars has also been identified. These include slip-type casing elevators, power tongs, and button-type slips as these all cause damage to the fiberglass tubular. Instead, normal serrated slips, soft slings, strap wrenches (**Fig.9**), and equipment from the pipe manufacturer have been advised (Romera et al. 2008).

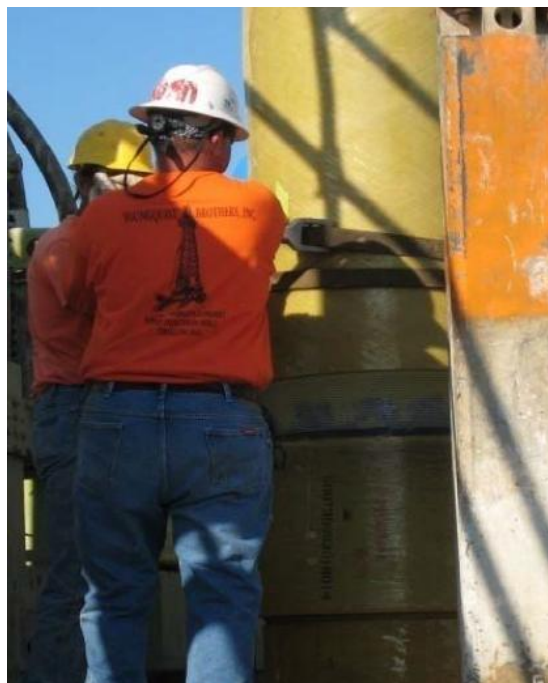
Figure9. Use of Strap Wrenches with Fiberglass Casing, courtesy of Future Pipe Industries
